VIBRATION ANALYSIS ON A PROPELLER SHAFT

Abstract-

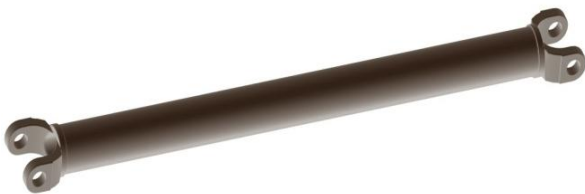
Fig.4 Propeller Shaft with U-Joint

The propeller shaft and universal joint is modelled using Pro/ENGINEER Wildfire 4, according to the dimensions and then assembled. The modelled propeller shaft with Universal joint is shown in the Figure.1 followed by the assembly of propeller shaft and universal in Figure 3.

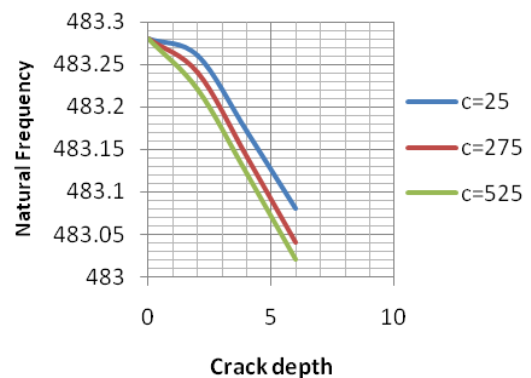
Fig 7: Title - Harmonic Analysis at Operating Angle $\alpha = 0^\circ$

At crack location $c = 25\text{mm}$ and crack depth $a = 2\text{mm}$, 4mm , 6mm and similarly with change in $c = 275, 525\text{ mm}$ Graph are plotted.

various positions and depth were obtained. The following graphs were plotted by interpolating the natural frequency obtained with crack depth. Natural frequency decrement of the propeller shaft system at operating angle $\alpha = 0^\circ$ for the crack depth (a) 2mm, 4mm, 6mm and crack locations (c) 25mm, 275mm and 525mm is plotted in the Figure 7

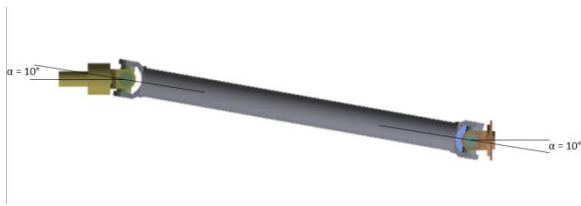
Fig.10 Propeller Shaft System at Operating angle $\alpha = 10^\circ$

The Harmonic analysis of the propeller shaft system at operating angle $\alpha = 10^\circ$ is carried out without crack and with crack at various crack depth and crack locations. The following diagram Figure 10 shows the propeller shaft system at operating angle $\alpha = 10^\circ$.
