STRUCTURAL BEHAVIOUR OF REINFORCED CONCRETE SQUARE COLUMNS DAMAGED BY REBAR CORROSION

Abstract

Key words: Steel Corrosion, Column, Axial behaviour, Energy absorption capacity, Weight Loss.

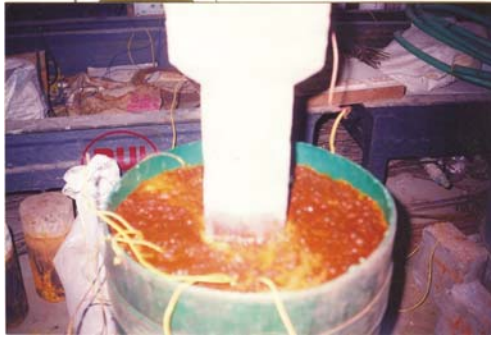
Fig. 1. Accelerated Corrosion Process

Galvanostatic method was to accelerate the corrosion of the reinforcement. This method involved connecting the positive terminal of a DC power supply to the main reinforcement thus forcing it to become anodic. The negative electrode was then connected to a stainless steel plate placed in the electrolytic solution and the cathodic/anode surface area ratio of 3.7 were adopted. The scale model columns were placed in fibre reinforced plastic tank were subjected to a current of 5V. Two third portions of the columns were immersed in 3 % NaCl solution. Fig.1 shows the accelerated corrosion process of the specimen.

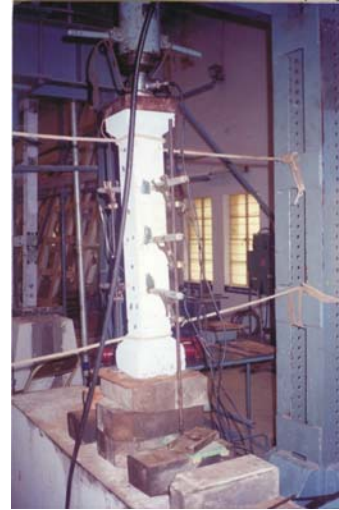
Fig. 3. Test Set - up - of Column S3UC

All specimens were loaded until failure under axial compression in a testing frame. The top of the column specimens were provided with a steel box of column size to ensure uniform distribution of the load on the specimen. Longitudinal strains were manually using DEMEC gauge with 150mm lengths having a least count of 0.002mm. Pellets were glued either on the concrete surface. Pellets were fixed at mid height of the column for strain measurements in the longitudinal direction. Strains were noted down for every 100kN increment of load. Test set up for the columns is shown in Fig. 2 and 3.

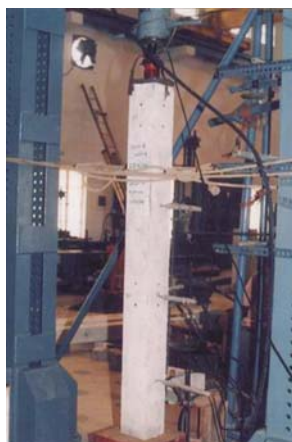
Fig. 2. Test Set - up - of Column S4UC

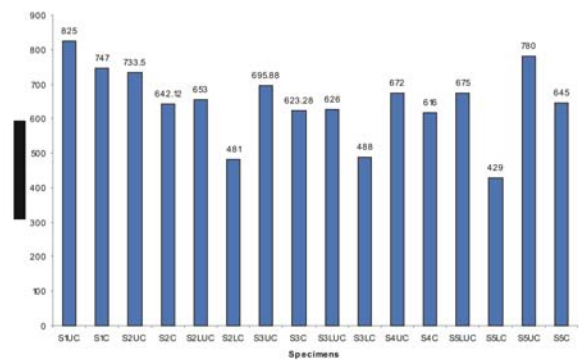
Fig. 4. Comparison of ultimate load between corroded and uncorroded column – S series specimens

The specimen attained the peak load of 825 kN. The axial strains were measured at eighty percentage of loading and energy absorption capacity was calculated for the area under the stress-strain curve. Specimen S1C reached an ultimate load of 747 kN which is 10 % less than S1UC. This can be ascribed to the deterioration of the bond at the steel to concrete interface caused by corrosion and reduction in the cross sectional area of the reinforcing bars. This is supported by the observation of a strain in about 1000 $\mu\epsilon$ (micro strain) which is 24 % less than the virgin specimens. The energy absorption capacity is reduced by 15%.

The second set specimens includes S2UC, S2C, S2LUC and S2LC. S2UC attained the maximum load of 734 kN followed in sequence by S2LUC, S2C and S2LC. Specimen S2C reached an ultimate strength of 642 kN, which is 1.14 times less than the conventional column. The axial strain decreases by a factor of 1.33 and energy absorption decreases by 1.36 times than the uncorroded column. The ultimate load observed in the specimen S2LUC was 653 kN, which is 1.12 times less than the conventional specimen. The axial strain and energy absorption are observed as 1.2 times less than S2UC.

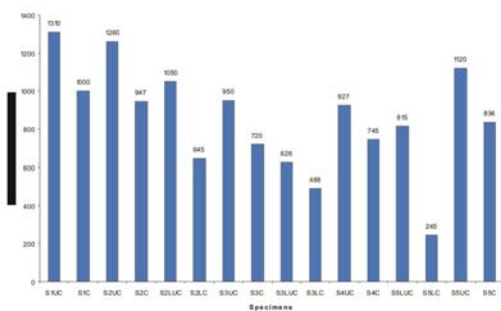
Fig. 5. Comparison of axial strain between corroded and uncorroded column – S series specimens

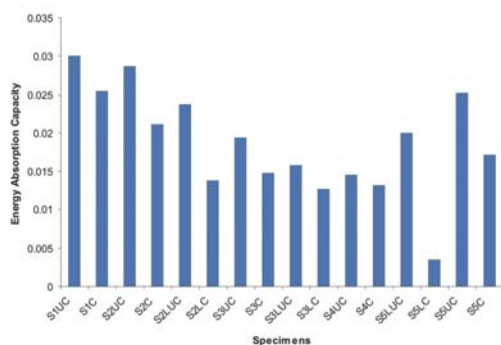
Fig. 6. Comparison of energy absorption capacity between corroded and uncorroded column – S series specimens

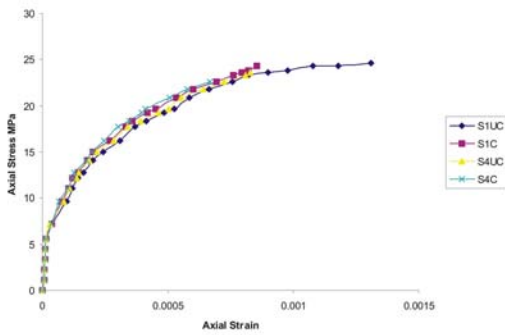
Fig. 7. Axial stress Vs axial strain for S1 and S4 series specimens

Typical Stress- Strain curves for uncorroded and corroded specimens are shown in Fig. 7 to 9. Each curve is an average of the stress-strain curves for the three identical specimens with the same level of corrosion. The axial rigidity of the column decreases due to corrosion. The above behaviour can be related to the development of cracks which may affect the failure mode and ultimate strength of the specimen through the significant loss of bond between concrete and reinforcement.

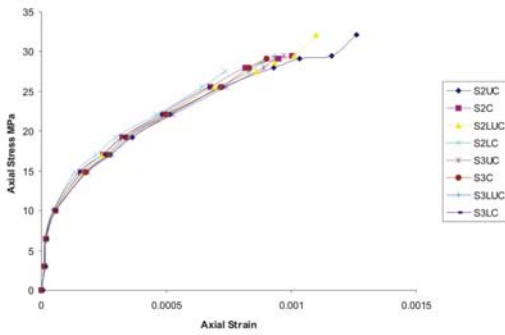
Fig. 8. Axial stress Vs axial strain for S2 and S3 series specimens

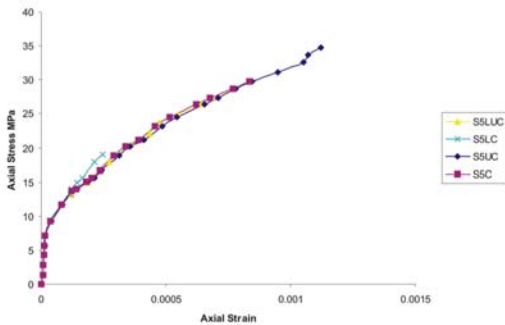
Fig. 9. Axial stress Vs axial strain for S5 series specimen

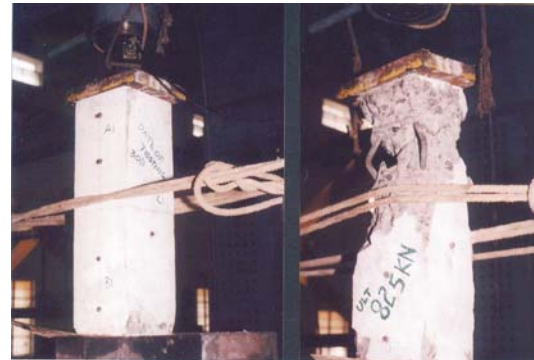
Fig. 11. Failure Mode of S1UC Specimen

In corroded column, the failure started in the lower corroded portion and extended over the entire specimen and disintegration of the concrete cover and core especially in the lower half of the columns. The spalling of concrete cover was caused due to corrosion cracks and it occurs all over the length. This premature mode of failure was accompanied by simultaneous buckling of longitudinal reinforcement. In the case of convention column, the fine irregular cracks were noticed in the surface of the columns. These cracks get widened with increase in load level and the concrete was crushed as the longitudinal reinforcement had yielded. Fig. 10 to 15 show the failure mode.

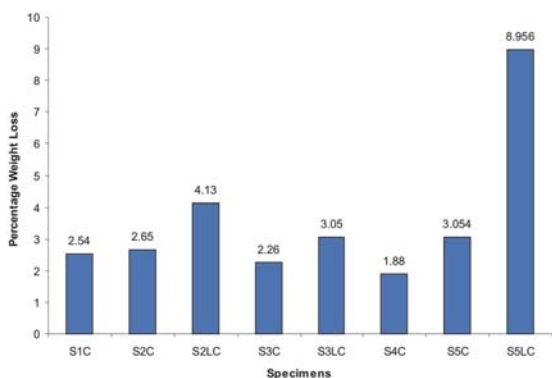
Fig. 16. Comparison of weight loss - S Series Specimens

The loss of weight of the rebars were calculated by the gravimetric method. Fig. 16 shows the percentage weight loss of the S series specimens. Fig. 17 shows the corroded rebars.

- ☞ The percentage loss of weight in steel increases with decrease in cover and the percentage decrease in load carrying capacity of the corroded column increases with increase in percentage weight loss of steel.

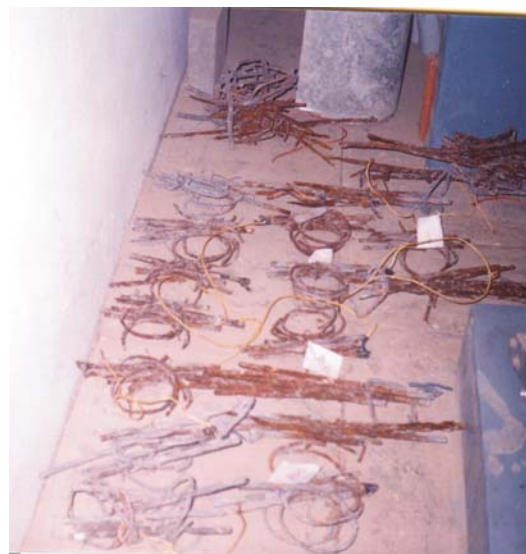
Fig. 17. Corroded rebars
